# Manhole Inspection Summary

Manhole # S19KK\_045MH

Insp Date: **6/5/07 7:46 AM**

**Location** Address: **2014 CLIFTON AVE**

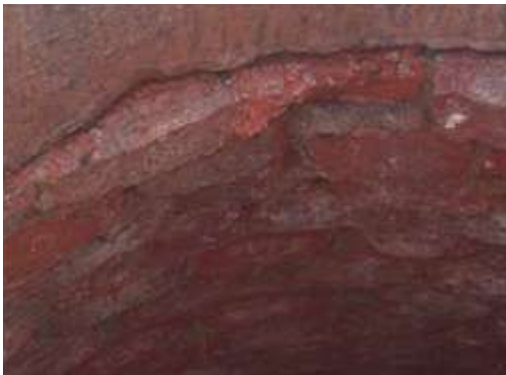
Defect 3

Condition: ☐ Sound ☐ Cracked ☐ Root Intrusion ☐ Loose Brick ☒ **Deteriorated**

DETERIORATION OF CHIMNEY

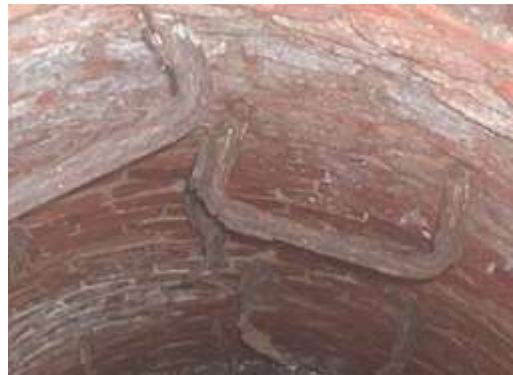
Defect 2

Count: **2** Missing: **3** ☒ **Corroded**

CORRODED STEPS AND MISSING

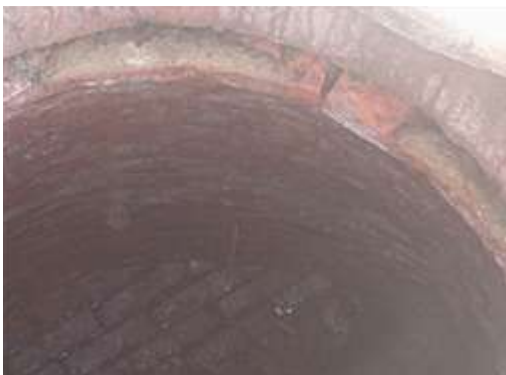
Defect 1

Offset: **1** (in.)

FRAME OFFSET

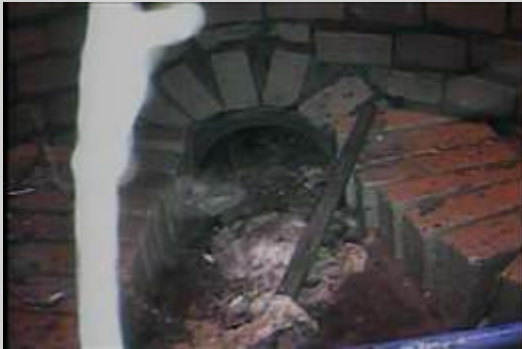
12 O'Clock Outflow

Pipe Height: **7.2** (in.) Rod and Bar (Angled)  
Pipe Material: **Clay** ☐ Pipe Lined  
Invert Depth: **8.61** (ft.) Flow Characteristics: **Slow**  
Deposits: ☐ None ☐ Mud ☐ Sludge ☒ **Debris** ☐ Grease  
Silt Depth: **3** (in.) Deposits Extent: **Medium**  
Infiltration: **None** Pipe Seal Cond: **Sound**

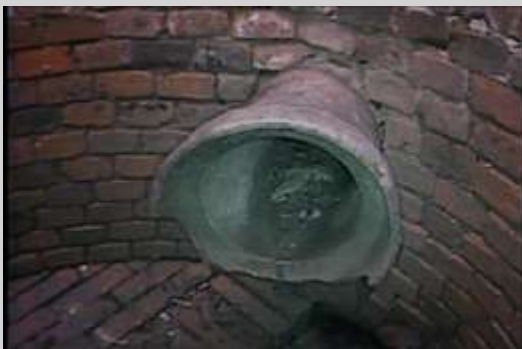
12 O'Clock Inflow

Pipe Height: **8.4** (in.) Rod and Bar (Angled)  
Pipe Material: **DIP/CI** ☐ Pipe Lined  
Invert Depth: **6.92** (ft.) Flow Characteristics: **None**  
Deposits: ☐ None ☐ Mud ☐ Sludge ☒ **Debris** ☐ Grease  
Silt Depth: **1** (in.) Deposits Extent: **Light**  
Infiltration: **None** Pipe Seal Cond: **Broken**

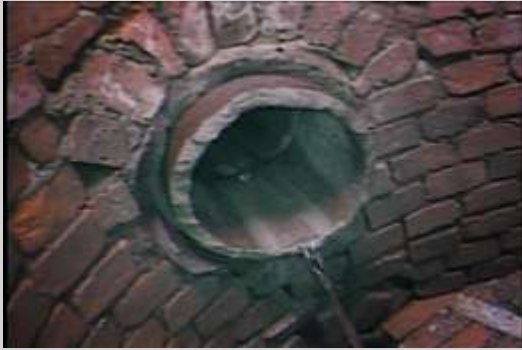
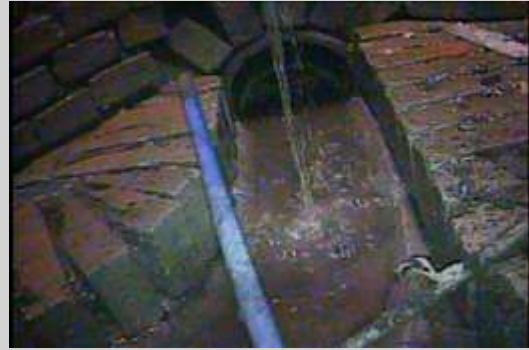
4 O'Clock Inflow

Drop Condition: **Partly Clogged**
